FAILURE ANALYSIS OF DIFFERENTIAL GEAR

In this study; BMC 935 trucks belonging to the spider and the spider shaft of the differential gear box damage were investigated. According to information received from the service, which is 138,000 miles spider, and the spider shaft broken, the damage has occurred. Differential gear unit and the shaft breaks the chemical composition spider, optical microscope, hardness and applying the failure analysis, the obtained results were evaluated in accordance with literature data.

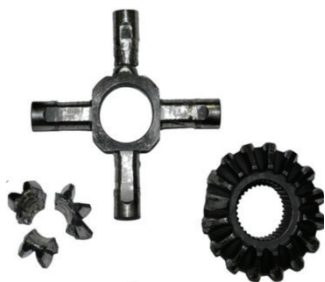
Figure 5. Broken spider gear and shaft

(Figure 3) and (Figure 4) show the differential gear boxes, axles and the spider gears. In this study, as seen in (Figure 5), the chemical composition, optical microscopy, hardness and damage analysis of broken, damaged spider and shaft on the study was conducted.

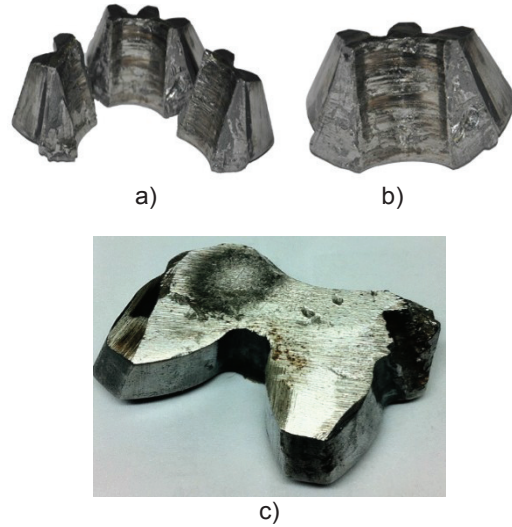
Figure 6: The broken spider gears (a,b,c)

(Figure 6a, 6b, 6c) show broken spider gears which is used in the chemical analysis. Materials of broken spider gear and shaft which were applied for the detection and microstructure were examined. AISI 4145H alloy steel was determined after examinations of the spider gear about kind of material (Table 1). Hardness value was measured as 641.67 HV (Vickers) (Table 2).

Metallographic studies and analysis result has been found that damage caused by fatigue. Fatigue crack began due to friction of spider gear with spider shaft.

Often used on slippery ground excavation of truck formed continuous loading and unloading on its spider gear and spider shaft. Therefore, spider gear and spider shaft have been broken because of fatigue.

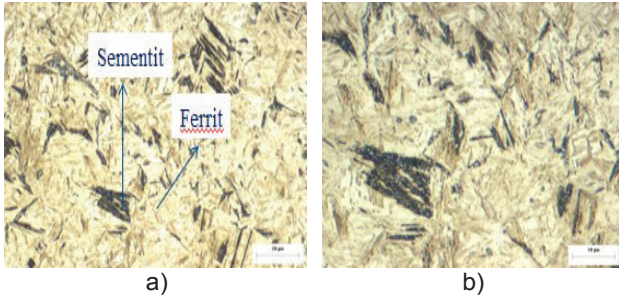
Figure 7. Spider gear microstructure appearance: a) 500x, b) 1000x

Cementite and ferrite structures are seen through (Figure 7). The damaged structure is a part pearlite and cross our gear. Eutectoid pearlite structure is a mixture containing 0.8% C and 723 C are formed by slow cooling. Ferrite and cementite in the form of a very thin layer or lamellar is formed from the mixture.

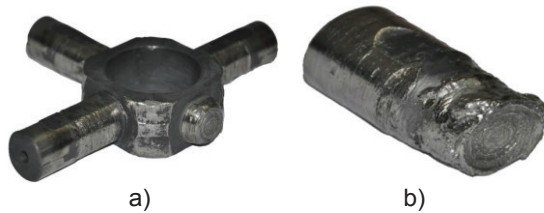
Figure 8. Broken Spider Shaft (a, b)

Images of the spider shaft fractures is also observed at (Figure 8). The first sign of the cross shaft fractures associated with physical observations, it is exposed to extreme fatigue and shaft diameter as a result of the decrease in strength has been made in reducing effects observed on.

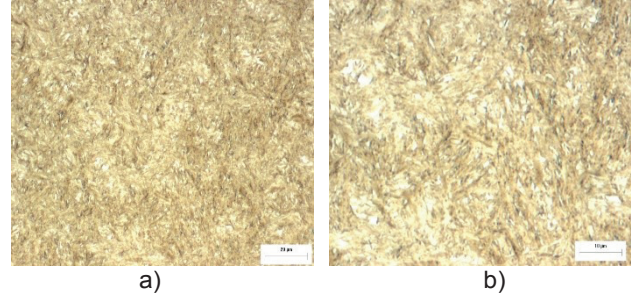
Figure 9. Spider shaft microstructure appearance: a) 500x, b) 1000x

The materials used in the star wheel shaft for detecting the applied chemical analysis and microstructure were examined. Examination of differential spider shaft material steel is AISI 4145H were observed (Table 3).

Hardness value was measured as 708,4 HV (Vickers) (Table 4).
